Using a dust control on an overhead grinder

Susan Shepherd, Silica and Noise in Construction Project

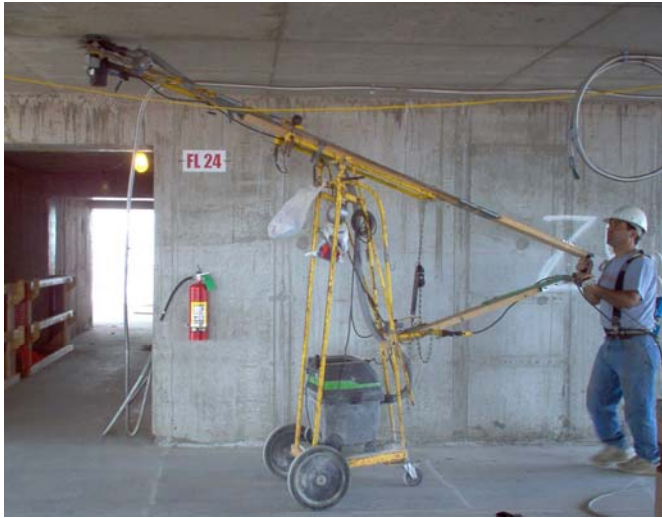
Grinding the concrete residue from forms on ceilings is often done by standing on scaffolds and ladders creating a severe ergonomic hazard due to working overhead. **S & F Concrete of Hudson, Mass.** has been using a “giraffe” for many years to lessen this ergonomic hazard. The “giraffe” is a homebuilt structure of welded tubing with wheels and a pivot arm to hold the grinder at the ceiling height. The laborer pushes the giraffe around the area and can pivot the grinder against the ceiling.

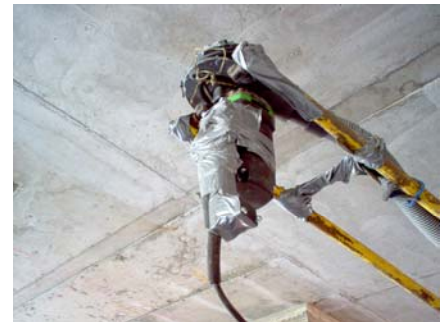
They asked their tool salesman to help solve the problem. He found a number of dust collector-grinder systems to fit on the cart, and they finally settled on one with a powerful enough grinder to be efficient for the work. This was the Eibenstock Model 1225 vacuum cleaner, rated at 130 CFM/ 98 in. water lift) and Model EBS 125 grinder (5 in. grinding wheel @ 10,000 RPM load speed). The trio along with site workers adapted the grinder to fit on the giraffe.

The grinder did burn out more often than the old one, increasing the expense of doing the grinding, but has been very effective at reducing the dust in the area. Not only is the health of the operator protected, but other workers may now work in the area. The greater productivity and reduced scheduling problems have offset the cost of the equipment.

Air sampling from U Mass Lowell (UML) documented the effectiveness of the dust collection. The respirable dust measured 0.094 mg/m³ and the respirable crystalline silica was “not detectable.” This is a good example of a subcontractor and general contractor working together to solve a problem to the benefit of workers’ health.
